Service Bulletin

Holland Fifth Wheels

Top Plate Rebuild vs. Replacement Criteria Inspection Check List

XA-351, XA-311, XA-331, XA-AL, XA-17,
XA-S1, XA-S2, XA-201, XA-231, XA-3501, and XA-2009 Series Top Plates

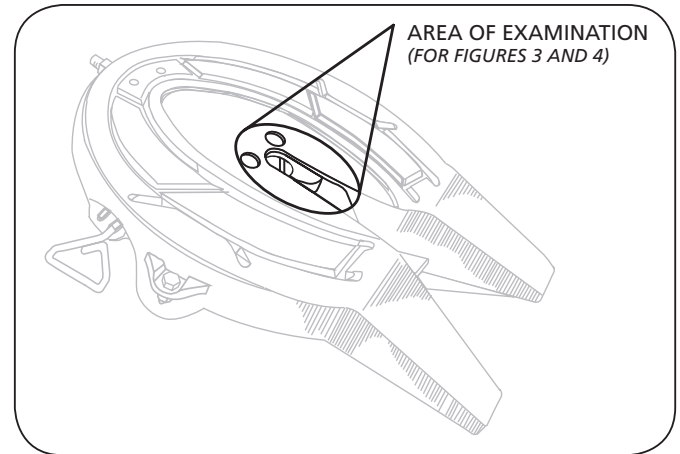
Figure 1

The fifth wheel top plate should be removed from the tractor and sufficiently cleaned *before* working through the checklist (**Figure 1**). This will allow the inspector to fully evaluate the points in the check list.

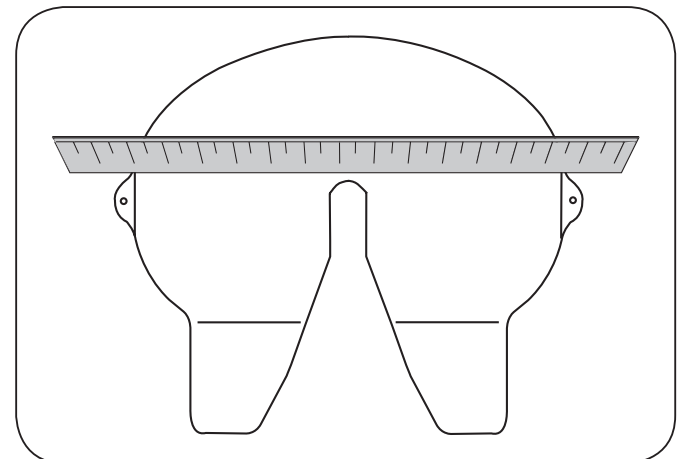
Figure 2

YES	NO
1. Perform a thorough inspection of the entire fifth wheel casting. Were any cracks discovered?	<input type="checkbox"/>	<input type="checkbox"/>
2. Is there any evidence of weld repair on the casting?	<input type="checkbox"/>	<input type="checkbox"/>
3. Measure the flatness of the top surface of the fifth wheel casting using a straight edge that reaches across the top plate from one side to the other. Is the top plate surface warped by more than 1/8" (Figure 2)?	<input type="checkbox"/>	<input type="checkbox"/>

NOTE: By holding the straight edge flat to the fifth wheel surface on one side of the center of the fifth wheel, and measuring the gap on the opposite side, you can accomplish this measurement.

If the inspector answers **YES** to *any* of the criteria, the top plate assembly is **NOT** a candidate for rebuilding, and should be replaced with an appropriate Holland replacement top plate.

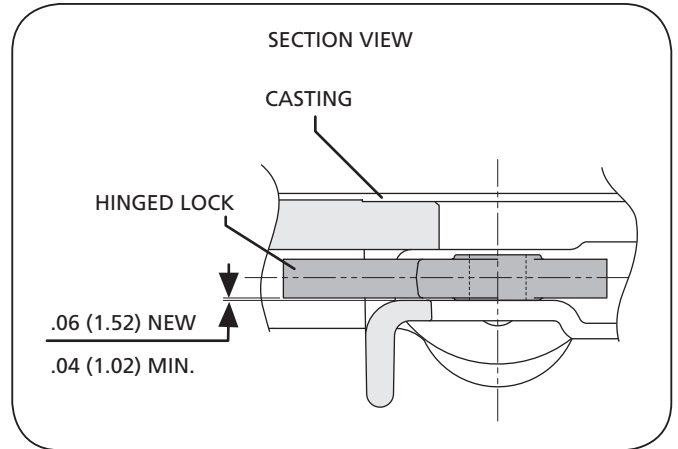
Figure 3

4. Is there evidence of damage to the top surface of the casting in the area where the lock components move to their open position during uncoupling (**Figure 3**)? YES NO

NOTE: The lock components should move freely into their unlocked position in the casting with a .040" minimum vertical clearance to the casting, both above and below the lock.

If the inspector answers **YES** to *any* of the criteria, the top plate assembly is **NOT** a candidate for rebuilding, and should be replaced with an appropriate Holland replacement top plate.

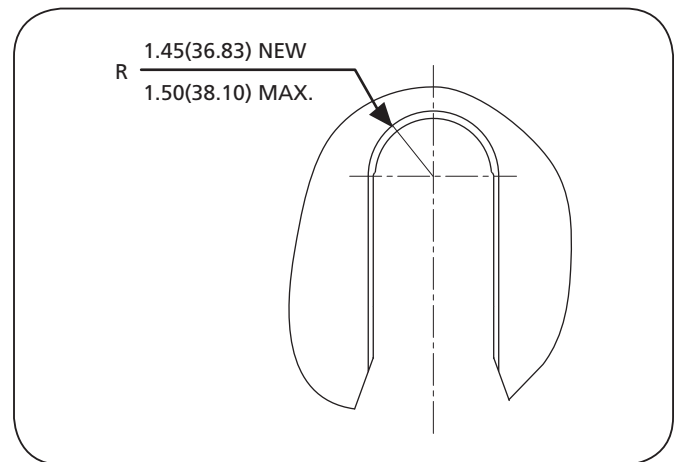
Figure 4

9. Check the radius of the front lock of the casting using a radius gauge. Is the radius 1.5" or greater (**Figure 4**)? YES NO

NOTE: This inspection does not apply to XA-311, XA-3501, or XA-2009 top plates.
