Type	Information
IB reg no	27x01
Date	06/12/2022
Pages	1

## OUTER COVER FIXING BOLT INSPECTION

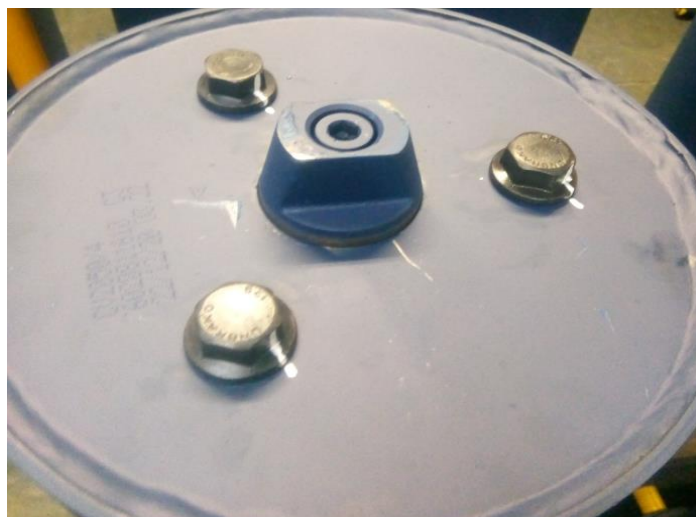
An incident has recently occurred with a vehicle where the outer cover had separated from the cylinder while tipping. This would have been prevented if the maintenance checks in the operator manual were carried out.

Figure 1 - Bolts match-marked after torqued at Edbro.

The recent incident shows that the tightness of these bolts can lead to cylinder damage and to the separation of the cylinder from the outer cover. Therefore, please treat this bulletin as a **safety critical** notice and ensure that these checks are included within your regular maintenance regime.

We would like to remind all customers and end users that we stipulate within our product operator manuals (Ref. Page 13 Maintenance Section – see attached) that the 3 bolts should be torque checked on an annual basis (12 month).

**The correct tightening torque for M16 bolts (22mm across flats) is 240 Nm**

**The correct tightening torque for M12 bolts (17mm across flats) is 150 Nm**
