SERVICE BULLETIN

24.08.06

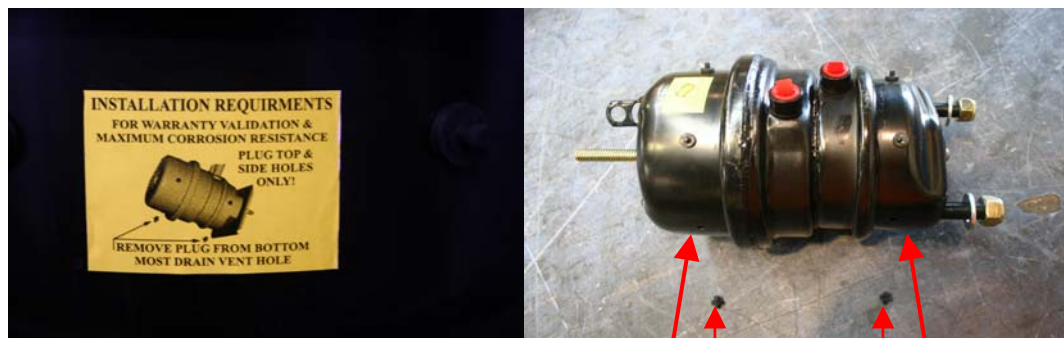
Chambers are shipped with all drain holes plugged as it is not possible to know final chamber orientation until fitted. Once fitted, the lowermost plug on each section, **must be removed**. Failure to do so invariably results in premature failure of the chamber.

Photos below show the label attached to each new chamber reinforcing this requirement, and location of plugs referred to. This requirement also applies to service chambers.

These are the plugs referred to and where they came from.
