## Service of the Hub Unit

**for wheel hub**

- 03 307 3043 00
- 03 307 3044 00
- 03 307 3045 00
- 03 307 3046 00
- 03 307 3056 00

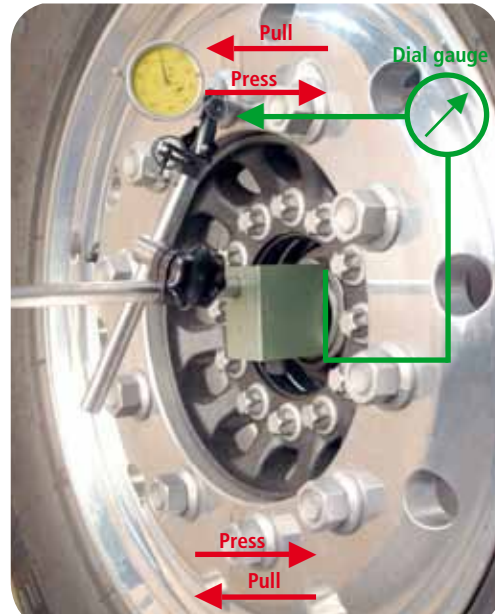
### Wheel rock test bearing 82 mm

1. Raise the wheel. **Do not remove the wheel!**
2. Carefully remove the wheel cap.
3. Check the prescribed tightening torque of the axle nut (900 Nm).
4. Position the magnetic foot of the dial gauge as shown on the right. Surface must be cleaned before.
5. By alternately pulling and pressing (first pull at the top an press at the bottom, then pull at the bottom and press at the top), rock the wheel and read off the travel on the dial gauge.  
**Rotate the wheel several times before each measurement!**

If a wheel rock of more than 0.25 mm (250  $\mu$ m) is measured, the hub unit has to be replaced.

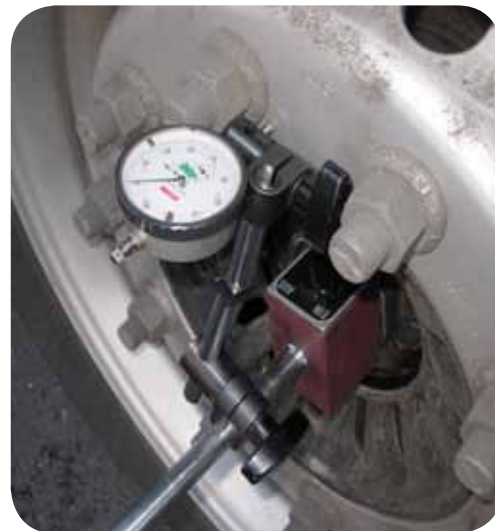
picture 1

### Wheel rock test bearing 88 mm

1. Raise the wheel. **Do not remove the wheel!**
2. Carefully remove the wheel cap.
3. Check the prescribed tightening torque of the axle nut (900 Nm).
4. Position the magnetic foot of the dial gauge as shown on the right (picture 1). Surface must be cleaned before.
5. By alternately pulling and pressing (first pull at the top an press at the bottom, then pull at the bottom and press at the top), rock the wheel and read off the travel on the dial gauge.  
**Rotate the wheel several times before each measurement!**

If a wheel rock of more than 0.22 mm (220  $\mu$ m) is measured, the hub unit has to be replaced.

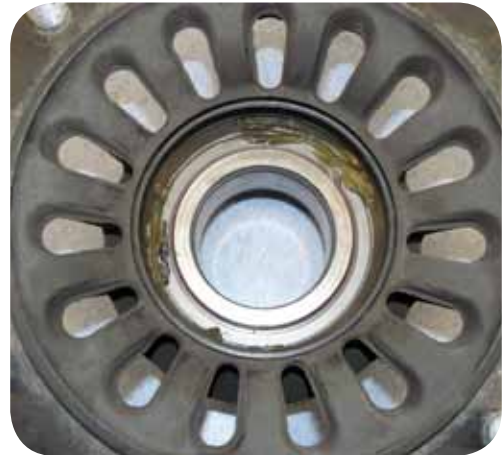
picture 2

Seal not completely covered (picture 2).  
Normal operating condition  
(= after a prolonged period of operation).  
Hub unit is OK.

„OK“

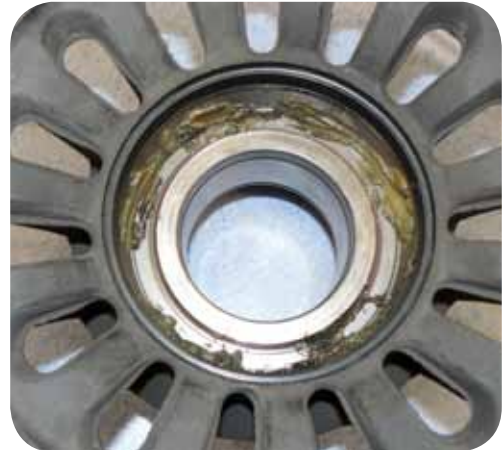
picture 3

Seal completely covered all over with tar-like grease (picture 3).  
Recommended measure:  
Replace the hub unit

„Not OK“

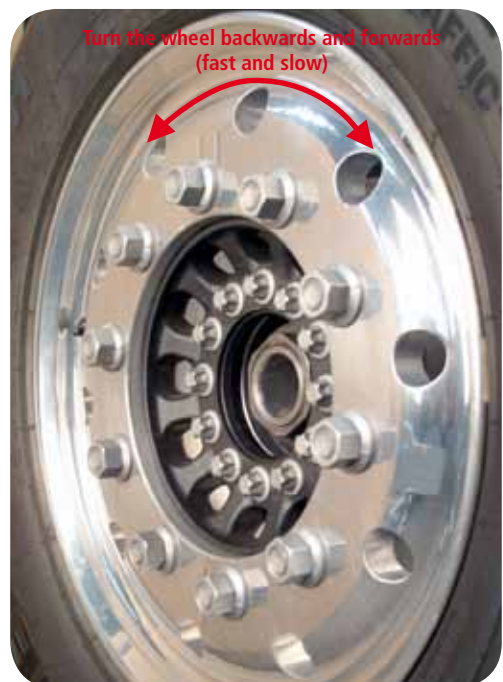
## 3 Wheel bearing noise test (bearing 82 mm and 88 mm)

Frictional noises from the brakes or „break-away effects“ – caused by the sealing gasket or grease – are normal and have no effect on performance.

The brake pads must be away from the brake disc.

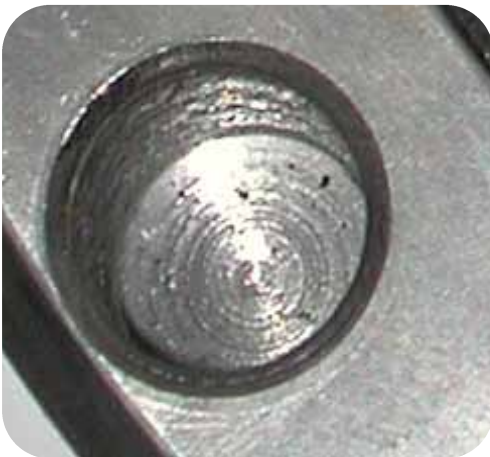
The discolouration is to be seen at the contact points to the brake disc and at the chamfer to the centering diameter or at the bottom of the blind holes (see figures). This discolouration is blue, red or occasionally tending to yellow.

„OK“

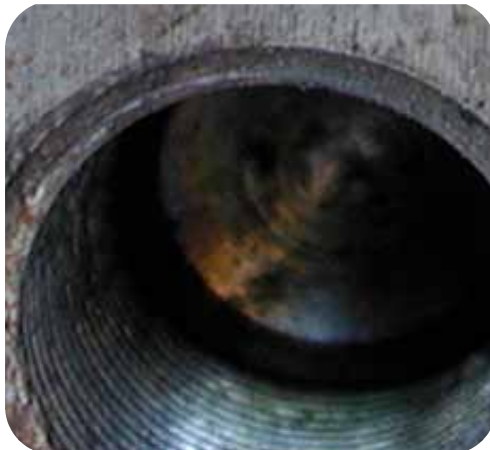
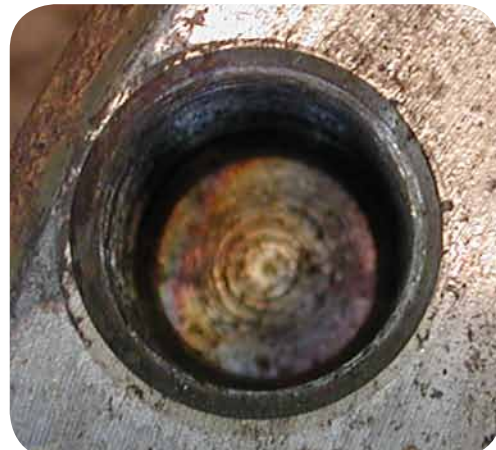
**Discolouration in this area can be caused by incorrect function/operation of the brakes. The brake system must therefore be checked for tractor/trailer brake synchronisation and for adaption.**

It must be assumed that particularly the grease or the bearing race and the seal have been subjected to thermal damage. If large amounts of grease escape at the same time from the outer seal (under the cap), the hub unit must be replaced.

„Not OK“

**Recommended measure: Replace the hub unit**
