# Drawbar Hinge Kit Maintenance

Applicable to RTBK & UTBK using the WT1202D-69315 Pin and T5524 Bushes

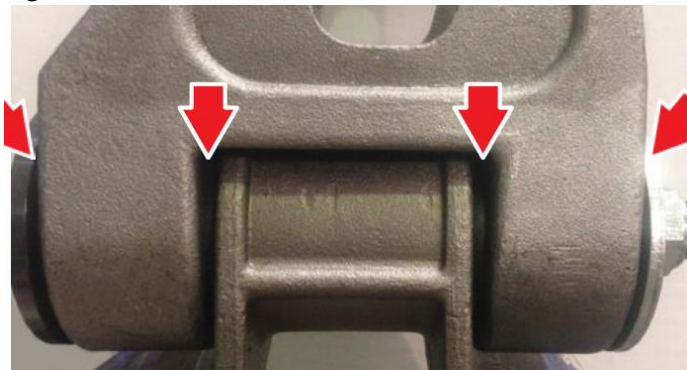
Fig 1

1. Make sure that all components are in place and that there is rubber present between the hinge components (see figure 1).

There should be a rubber bead formed in each of these areas, separating the metal components. It should be complete around the circumference and not split.

If any defects are found, the assembly should be repaired immediately, and any faulty components replaced.

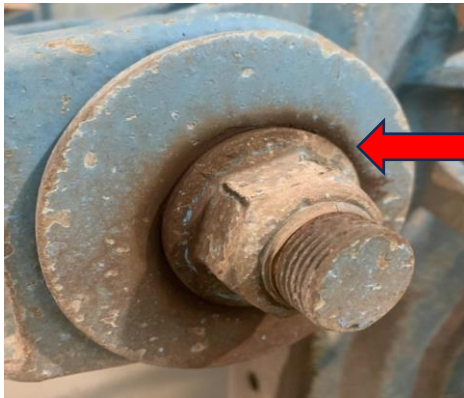
Fig 2

2. Make sure the pin is in place and secure. Look for tell tales of an insecure pin assembly around the brackets, nut and washer (see figure 2).

These black marks should not be present on a secure connection. If they are, then replace the pin kit and bushes.
